MARYLAND INVENTORY OF HISTORIC PROPERTIES

Survey No. B-4331 Magi No.

9					
1. Nam	(indicate pro	eferred name)				
201201000000000000000000000000000000000	108 N. Howard S	Street				
historic	Jeans Fair					
and/or common

B-4331 Jeans Fair 108 N. Howard Street Block 0619, Lot 031 Baltimore City

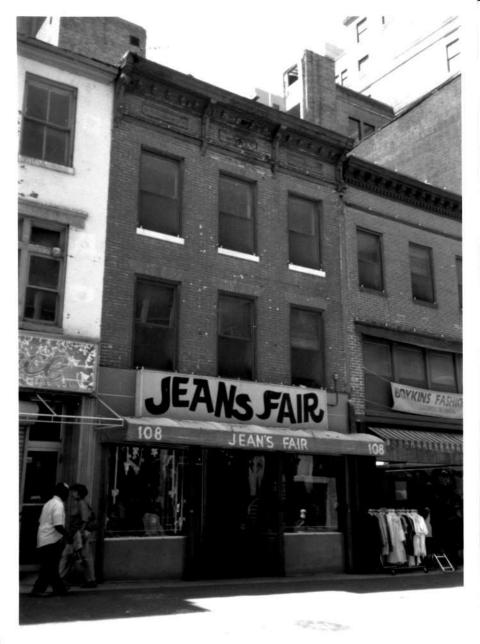
B-4331 108 N. Howard St. Balkmore WD Drane Shaw 8/91 Maryland SHPO Facade, east elevation 1/2

This circa 1875 commercial building faces east on N. Howard Street and abuts two partywall structures. The building is has three bays, three stories, and a painted brick facade. It has a street frontage of 20' and a depth of 64'6".

The first story has been substantially altered circa 1940-1950. It has a moderately recessed entrance in the middle bay that is flanked by display windows. The windows sit upon a foundation wall that is faced with blue enamelled panels. The panelling continues over the facade of the first story. An awning and a sign board are suspended over the first story.

The second story has three 1/1 sash windows with brick splayed jack arches. The sills are obscured by the blue enameled panels. The third story has three 1/1 sash windows with brick splayed

jack lintels and stone sills.

An elaborate cornice runs across the top. The projecting cornice has raised blind arches. An angled soffit runs below this; it has jig-sawn scrolled ventilator openings and applied ornamental scrolls. Scrolled brackets with elongated pendants with jig-sawn designs are positioned below the soffit. The drop of the brackets divide the cornice into three spandrel-like zones. Each spandrel is embellished with panels of jig-sawn ventilator openings.

A small pedimented dormer is situated on the gable roof

between the first and second bays.

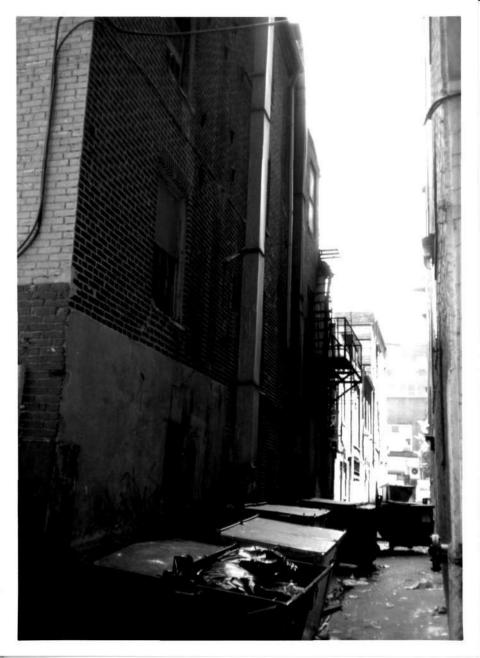
B-4331 108 N. Howard St (rear) Baltimore MD Drane Shaw 8/91 Maryland SHPO Rear alley (west elevation)

An attached back building extends from the first two bays of the main building. The back building faces the alley (State Street). It is two stories high, two bays long and one bay wide. The west wall has been altered; the old loading dock is now a ventilator. The second story loading dock is also blocked up. Both docks had wood lintels. A shed roof awning is suspended over the windows on the south wall. The west wall of the main building has windows in the third bay of the second and third stories.
